## MEMORANDUM

DATE: 27 August 2003

RE: Preliminary Assessment/Site Investigation Activities at the Oak Street Site.  
TDD No. 03-05-0176; Task No. 6181; Document Control No. R-2254.

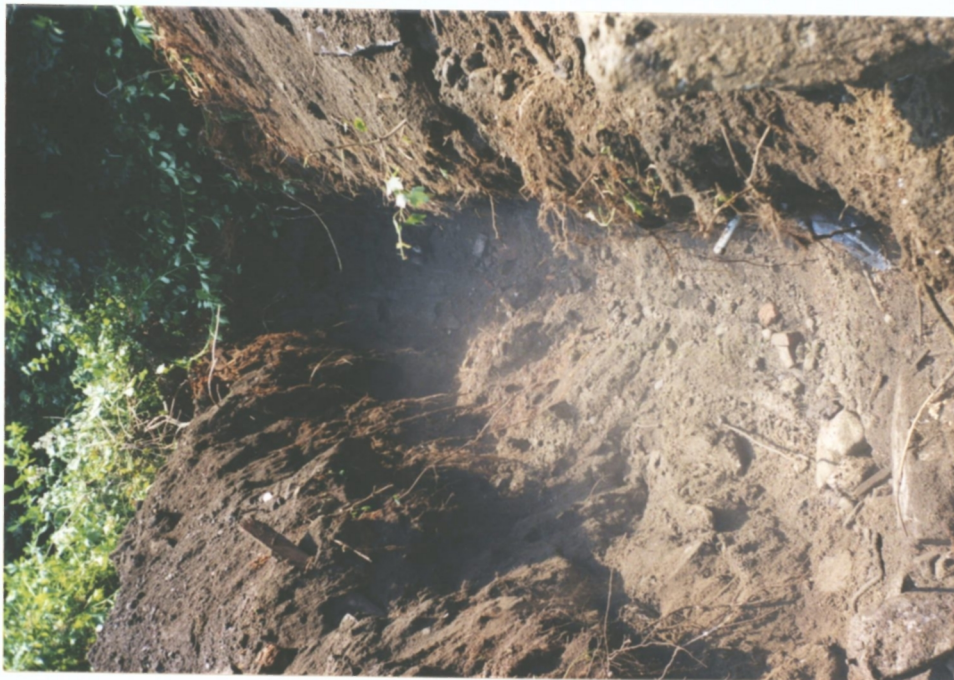
**FRAME NUMBER:** 0A    **DATE:** 27 June 2003  
**PHOTOGRAPH BY:** Dan Muzrall  
**CAMERA:** Olympus    **SETTING:** Automatic

**SCENE:** View of the excavated area. Photograph taken facing north.

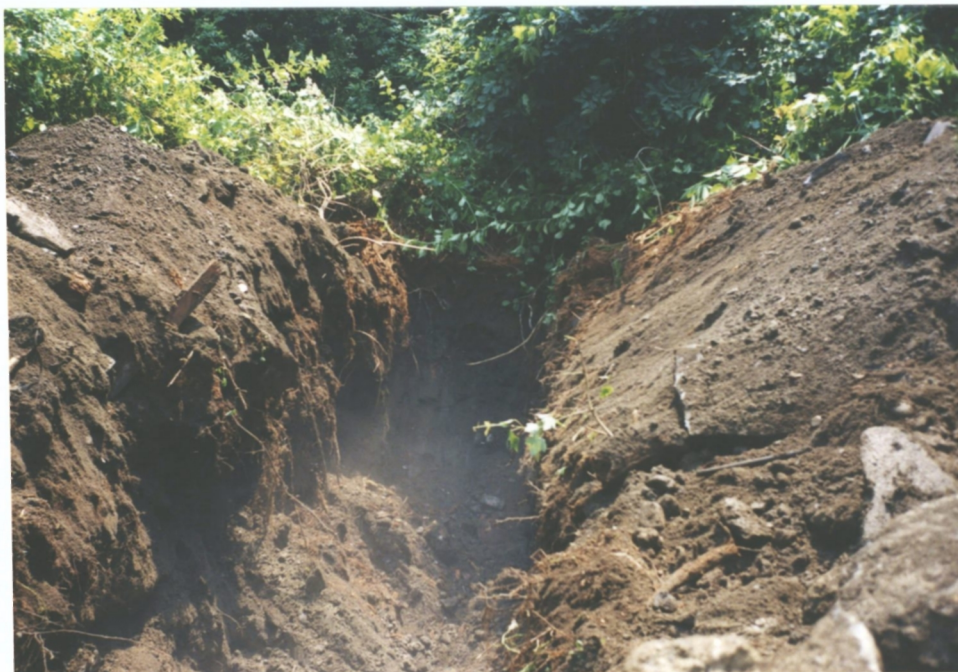
**FRAME NUMBER:** 1A    **DATE:** 27 June 2003  
**PHOTOGRAPH BY:** Dan Muzrall  
**CAMERA:** Olympus    **SETTING:** Automatic

**SCENE:** View of the excavated area. Photograph taken facing north.

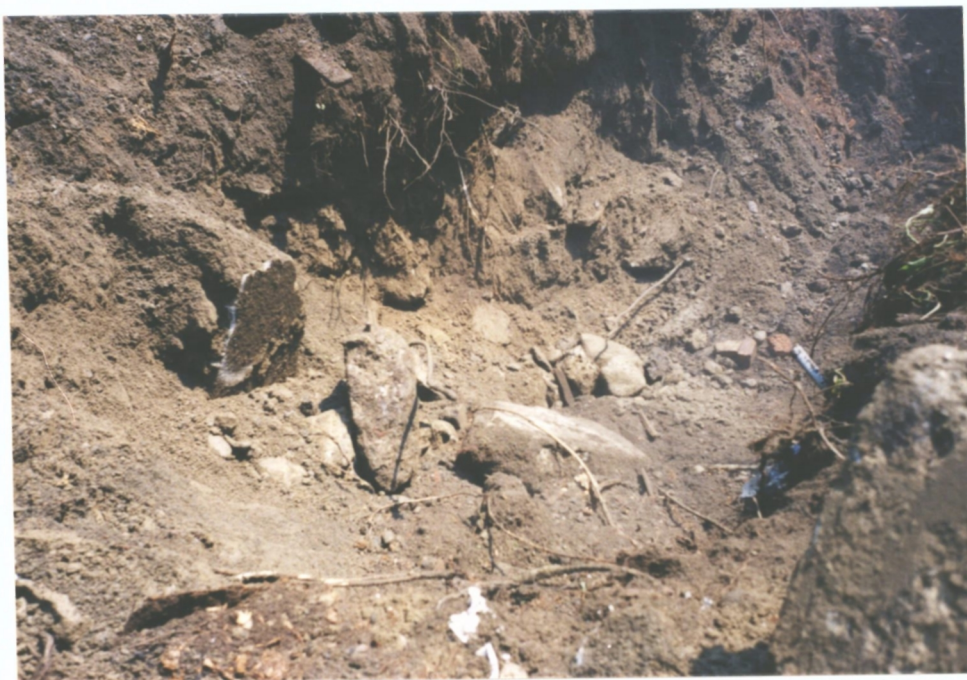
**FRAME NUMBER:** 2A    **DATE:** 27 June 2003  
**PHOTOGRAPH BY:** Dan Muzrall  
**CAMERA:** Olympus    **SETTING:** Automatic

**SCENE:** View of debris in the bottom of the excavation. Photograph taken facing northwest.

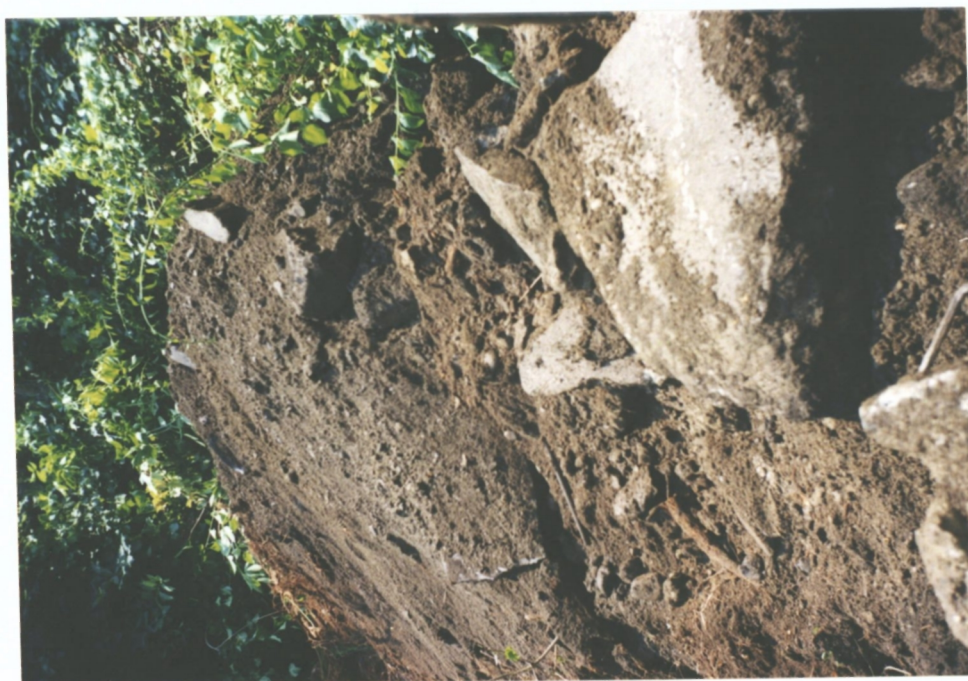
**FRAME NUMBER:** 3A    **DATE:** 27 June 2003  
**PHOTOGRAPH BY:** Dan Muzrall  
**CAMERA:** Olympus    **SETTING:** Automatic

**SCENE:** View of excavated soil from the test pit containing construction and demolition debris. Photograph taken facing northeast.

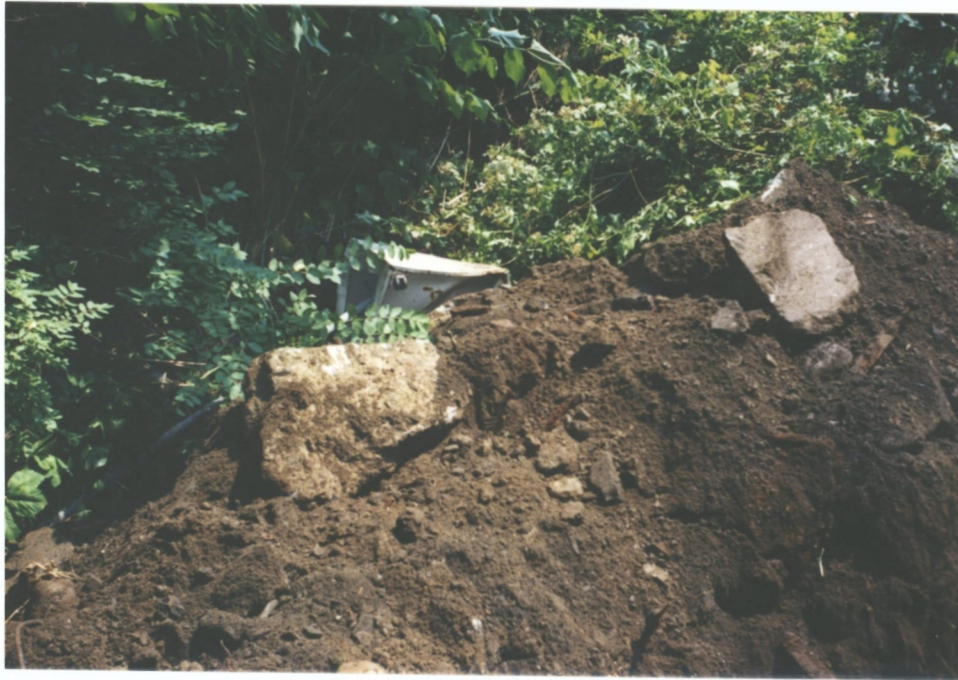
**FRAME NUMBER:** 4A    **DATE:** 27 June 2003  
**PHOTOGRAPH BY:** Dan Muzrall  
**CAMERA:** Olympus    **SETTING:** Automatic

**SCENE:** View of excavated soil from the test pit containing debris. Photograph taken facing east.

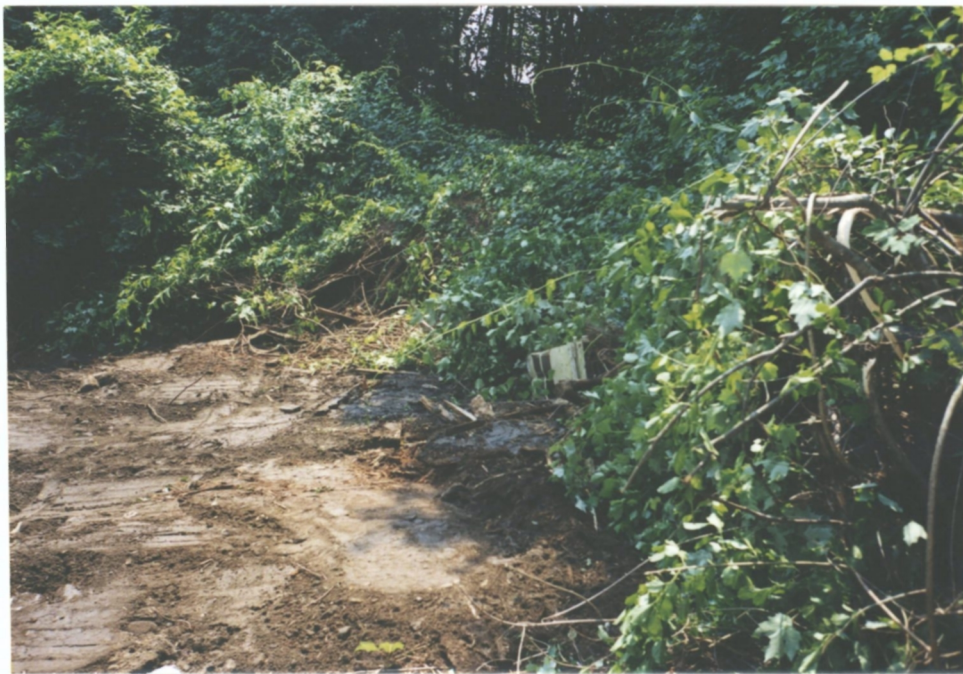
**FRAME NUMBER:** 5A    **DATE:** 27 June 2003  
**PHOTOGRAPH BY:** Dan Muzrall  
**CAMERA:** Olympus    **SETTING:** Automatic

**SCENE:** View of the backfilled and compacted test pit area. Photograph taken facing northwest.

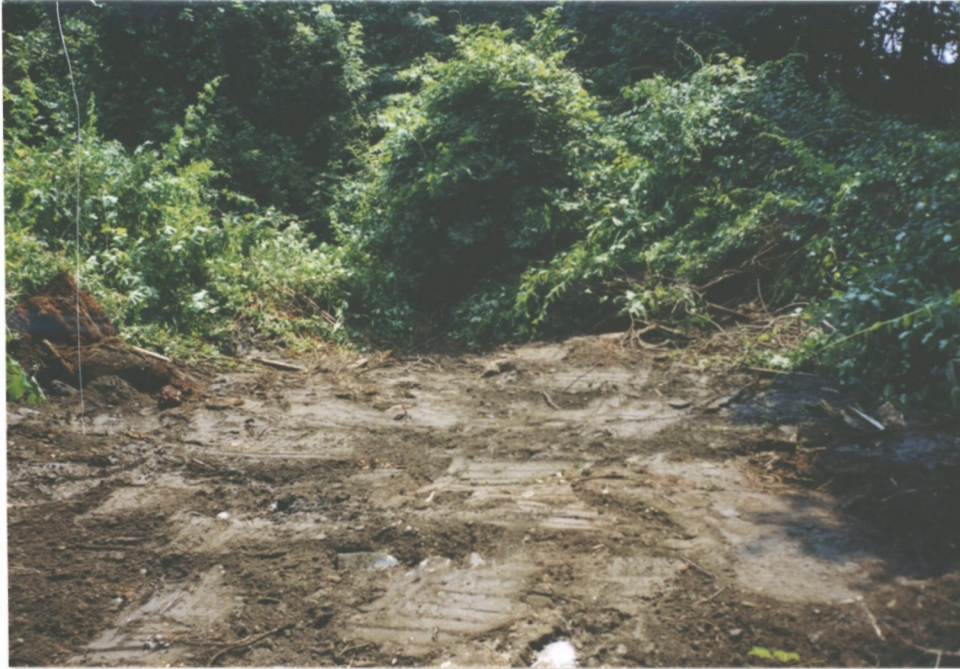
**FRAME NUMBER:** 6A    **DATE:** 27 June 2003  
**PHOTOGRAPH BY:** Dan Muzrall  
**CAMERA:** Olympus    **SETTING:** Automatic

**SCENE:** View of the backfilled and compacted test pit area. Photograph taken facing north.

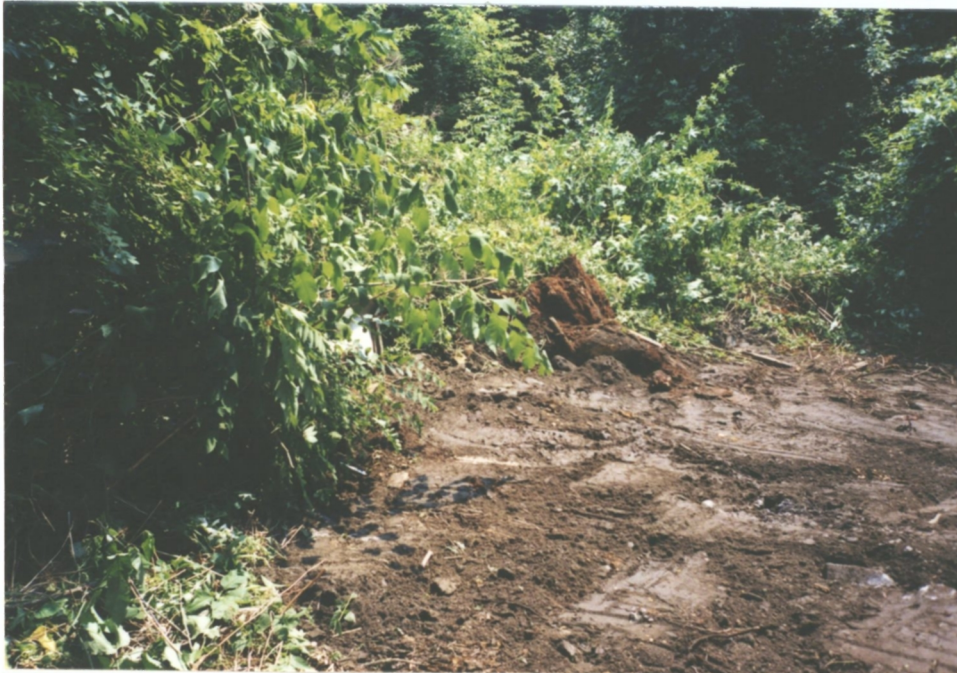
**FRAME NUMBER:** 7A    **DATE:** 27 June 2003  
**PHOTOGRAPH BY:** Dan Muzrall  
**CAMERA:** Olympus    **SETTING:** Automatic

**SCENE:** View of the backfilled and compacted test pit area. Photograph taken facing northeast.
